CASE STUDY

✓ Bladestar Renewables Ltd were tasked with a Category 5 repair to a LM 45.0P blade which had sustained serious damage. Damage was located 5-7m from the root.

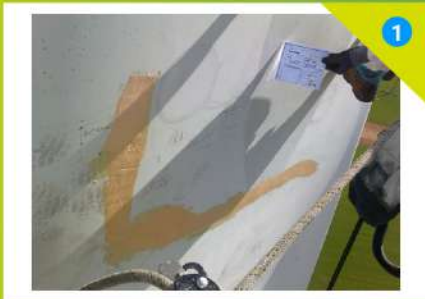
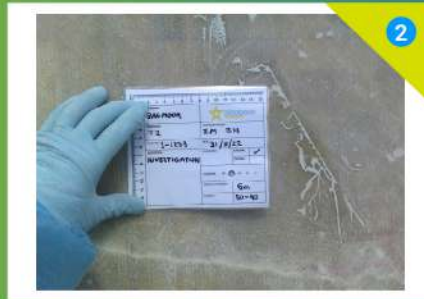
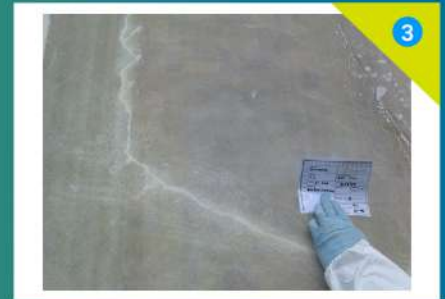
Investigation

The works were started with a thorough investigation of the external and internal crack. It was deemed that there was minimal SPAR damage during the investigation.

All layers of fiberglass and core were damaged resulting in a core replacement. This was chosen to be completed internally after the external fiberglass layers had been replaced making the damaged area water tight.

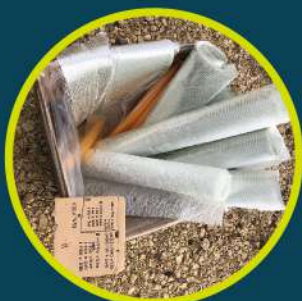
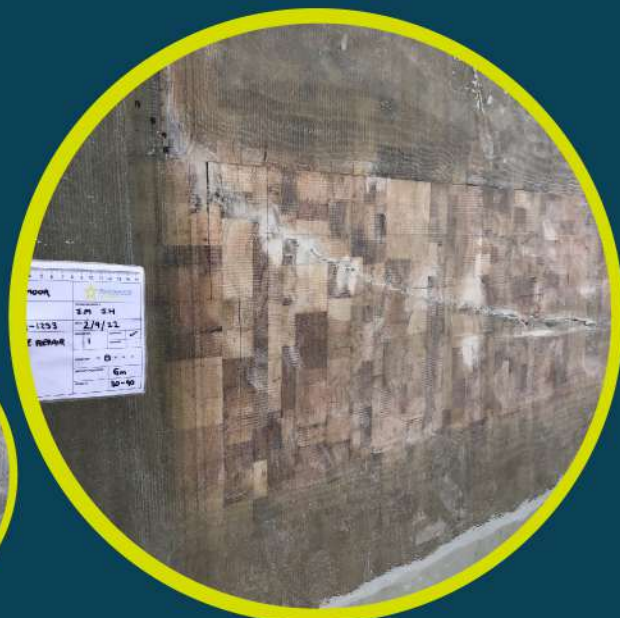
External Repair

External fiberglass layers removed exposing crack in the core material. The fiberglass layers were chamfered and replaced in accordance with our work instruction for this repair.

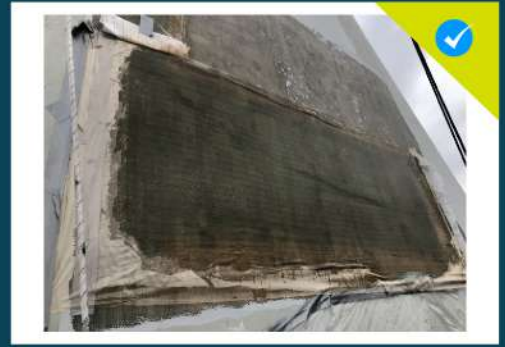
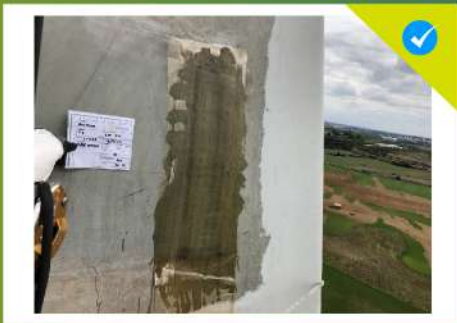
x4 separate structural laminations were applied to the affected area to rebuild the layers that had been removed. These extra structural laminations were necessary due to the incorrect removal of the spoiler. Cuts were found in the outer fiberglass layers which had been filled with paint. Due to the nature of these cuts being at varying angles causing structural stress' across the area these were removed.

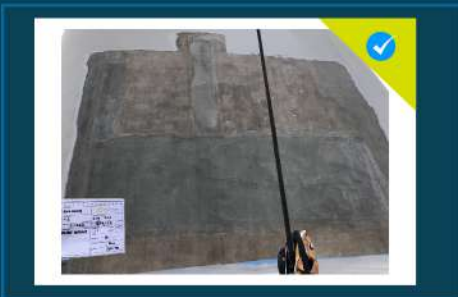
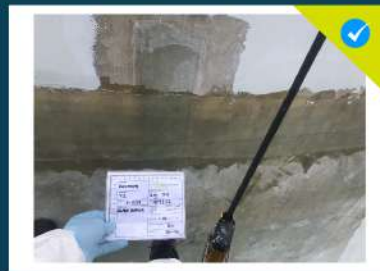
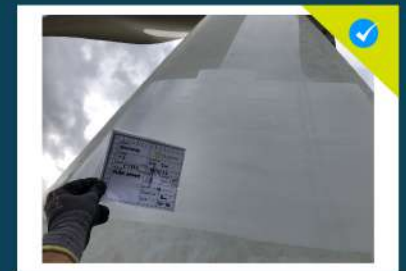
Additional fiberglass was layered over the top of the structural laminations in order to spread the load across a greater surface area. This was completed in order to reinforce the original defect.

Upon completion of the laminate, the area was filled using sacrificial laminate and filler to restore blade profile. Filler then sanded and painted.

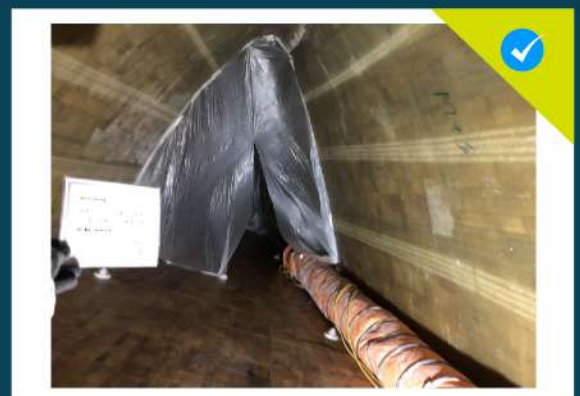
Internal Repair

Cracks were found to mirror the external defect. As a result of already identifying the core damage we were able to move straight into core replacement reducing the need for further investigation.

Minor cracks were identified across the web foot. As a result of this it was decided they would be removed and the cover laminate for the main defect would overlap from shell onto webfoot/web.

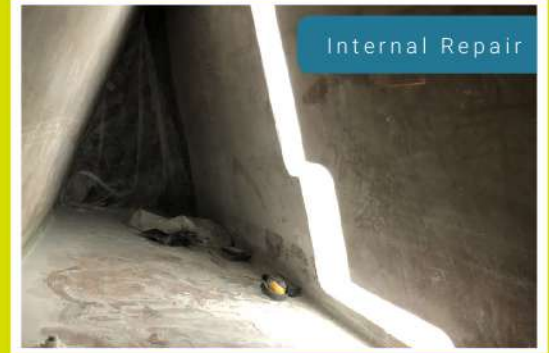
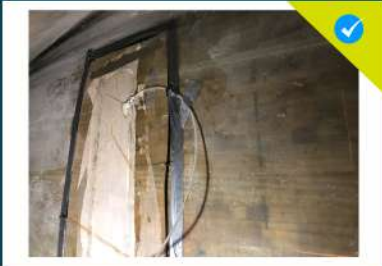
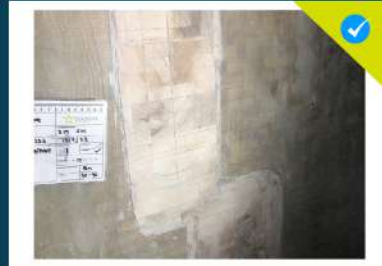
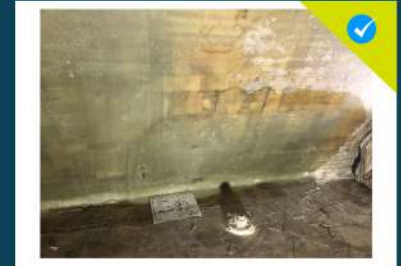
New core was bonded into place and vacuum consolidated to promote superior adhesion to the outer laminate.

Structural lamination was then completed and heat treated to improve strength.

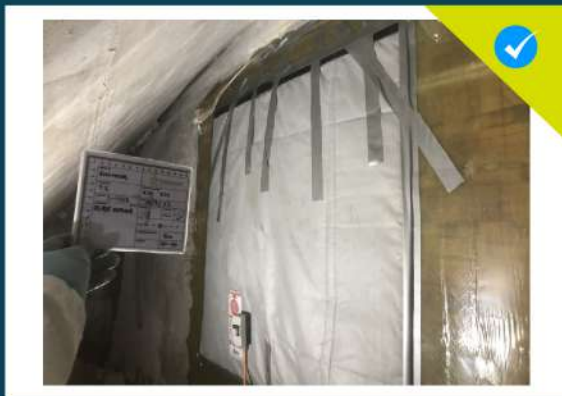
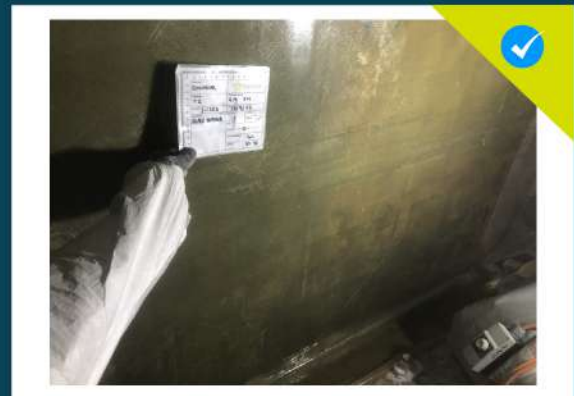
Cover laminate applied in order to spread the load over a greater surface area and to encompass the webfoot and web reinforcements.
