CASE STUDY
BROCHURE

BLADE
REPAIR SPECIALISTS

LEADING

EDGE EROSION

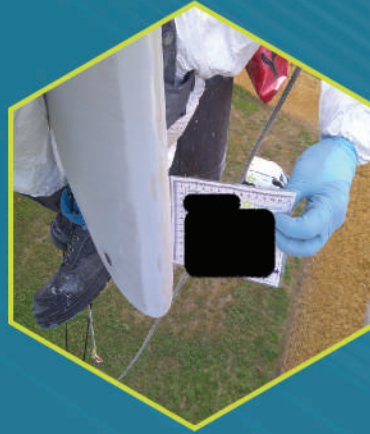
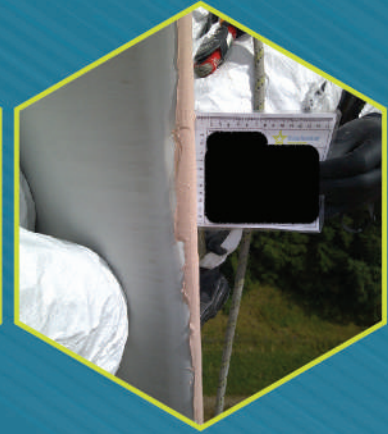
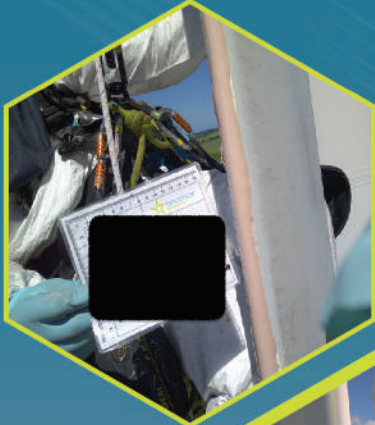
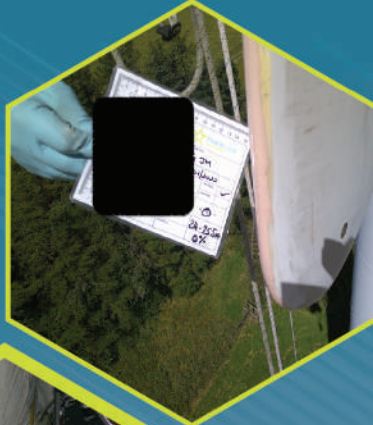
Bladestar Renewables Ltd were tasked with completing Category 2 Leading Edge Erosion repairs on x3 vestas blades. The blades were in general good health however had fallen victim to leading edge erosion with no protection applied at factory.

Each blade had approximately 3 metres of leading edge erosion. The inspection photo's were blurry therefore we were unsure as to the extent of the damage ie; paint, filler or laminate damage.

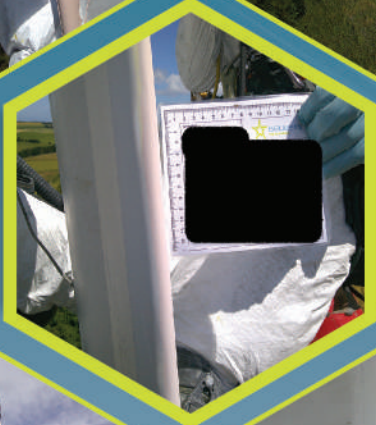
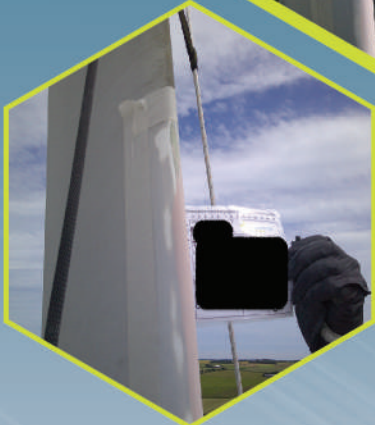
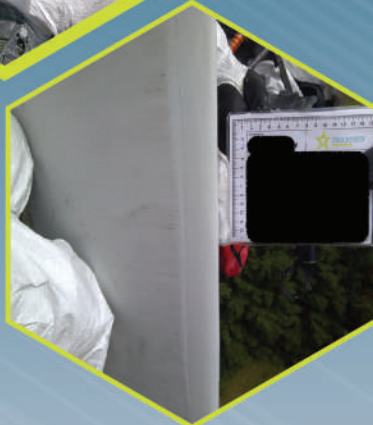
Upon starting the works via rope access, we were pleased to see that the damage was minimal. Mostly paint and filler erosion with some CSM laminate damage but well below our structural damage laminate guidelines.

Damaged filler and paint were removed and replaced with a stronger brand of filler and repainted with a 2K paint. Small additional damages were found during the scheduled repairs. We consulted with the customer and we were able to complete these on the same visit.
