Earlsburn Internal

WEB REINFORCEMENT

Bladestar Renewables Ltd were tasked with completing a Category 3 internal repair to a LM blade. The identified defect was a result of operational fatigue.

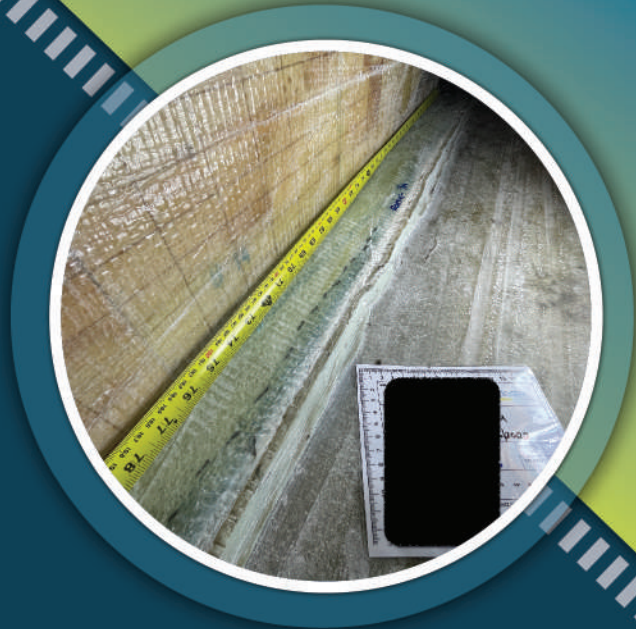
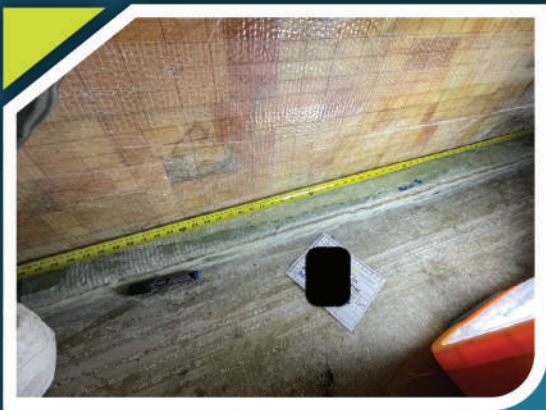
The damage was located 8 metres from the root on the suction side. In section 2 of the blade, Web B had suffered debonding from the internal shell. The total distance of the debonding was around 4 metres.

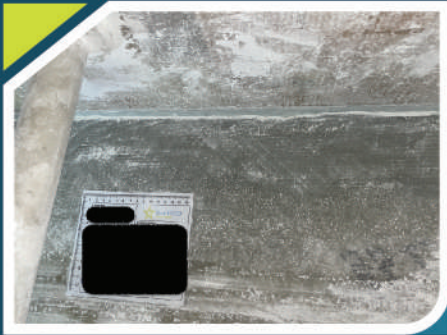
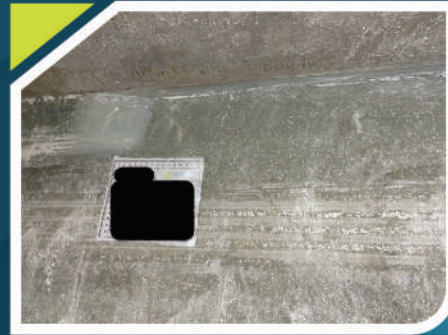
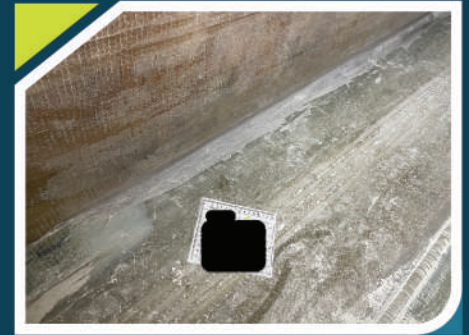
In order to correctly identify the depth of the debonding/glue cracks in the web foot we had to begin by removing top layers of fiberglass. Once the fiberglass layers were removed, the glue that is used during production to bond the web to the internal shell was exposed. It was clear that the glue was cracked in its entirety. There were also areas of uncured bonding paste found in some areas. This led us to our root cause analysis.

Upon recording that the glue was substantially damaged, it was decided that we would remove all glue from the web foot. This left the Web and Inner shell free from any glue and sitting at a 90 degree angle.
