CASE STUDY

TASK

✓ Bladestar Renewables Ltd were tasked with a Category 5 repair to a LM 45.0P blade which had sustained serious damage. Damage was located 5-7m from the root.

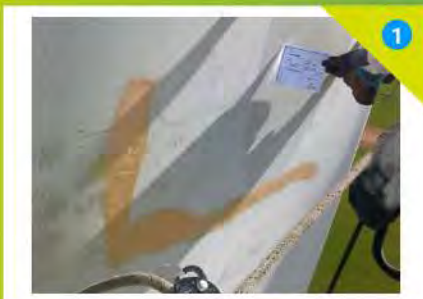
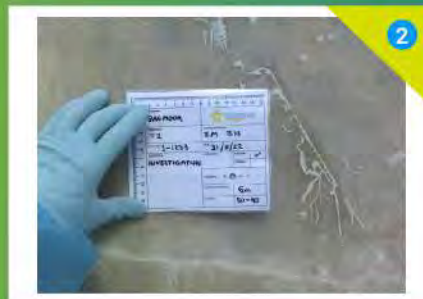
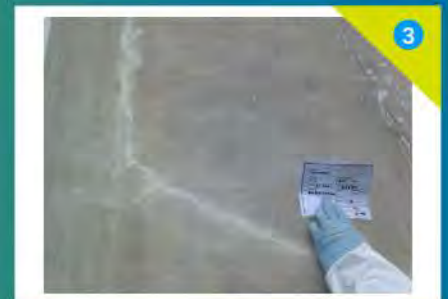
Investigation

The works were started with a thorough investigation of the external and internal crack. It was deemed that there was minimal SPAR damage during the investigation.

All layers of fiberglass and core were damaged resulting in a core replacement. This was chosen to be completed internally after the external fiberglass layers had been replaced making the damaged area water tight.

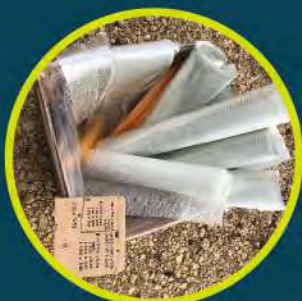
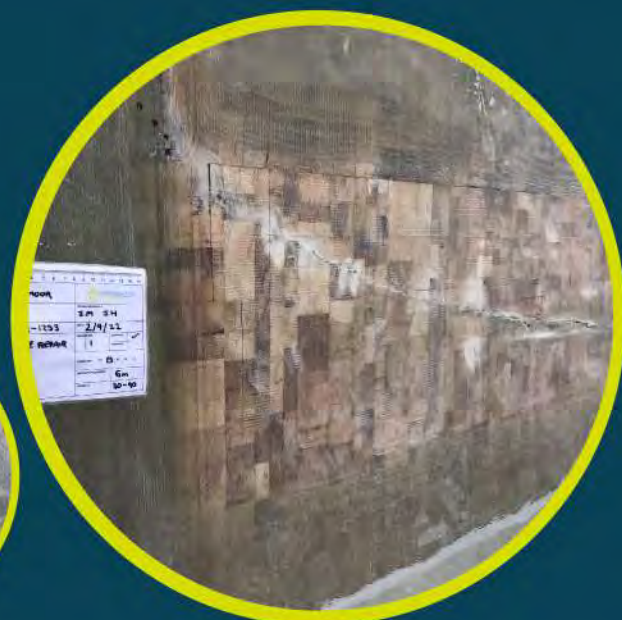
External Repair

External fiberglass layers removed exposing crack in the core material. The fiberglass layers were chamfered and replaced in accordance with our work instruction for this repair.

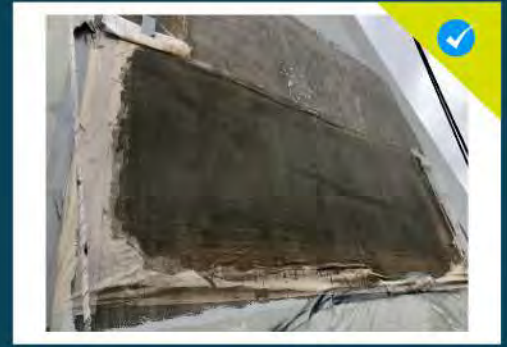
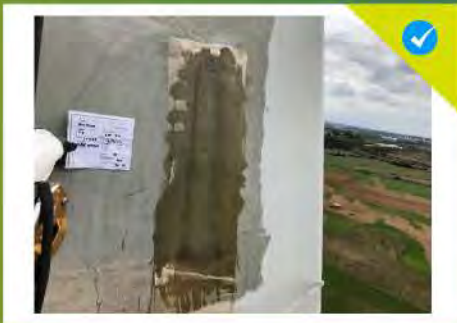
x4 separate structural laminations were applied to the affected area to rebuild the layers that had been removed. These extra structural laminations were necessary due to the incorrect removal of the spoiler. Cuts were found in the outer fiberglass layers which had been filled with paint. Due to the nature of these cuts being at varying angles causing structural stress' across the area these were removed.

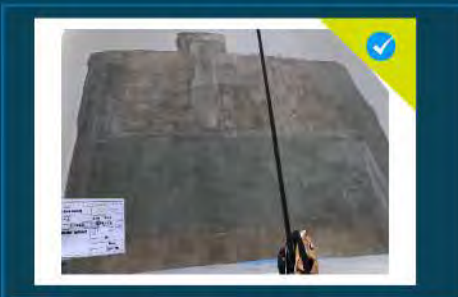
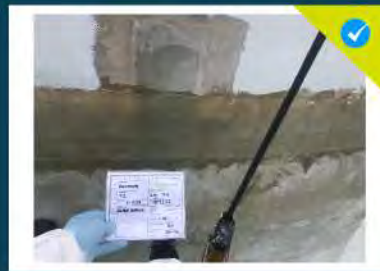
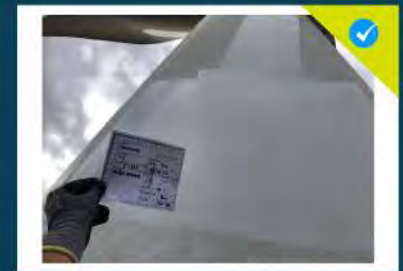
Additional fiberglass was layered over the top of the structural laminations in order to spread the load across a greater surface area. This was completed in order to reinforce the original defect.

Upon completion of the laminate, the area was filled using sacrificial laminate and filler to restore blade profile. Filler then sanded and painted.

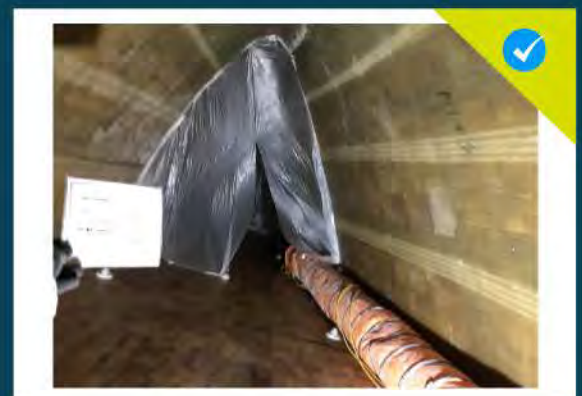
Internal Repair

Cracks were found to mirror the external defect. As a result of already identifying the core damage we were able to move straight into core replacement reducing the need for further investigation.

Minor cracks were identified across the web foot. As a result of this it was decided they would be removed and the cover laminate for the main defect would overlap from shell onto webfoot/web.
