BLADE
REPAIR SPECIALISTS

MST TOWER SEALING

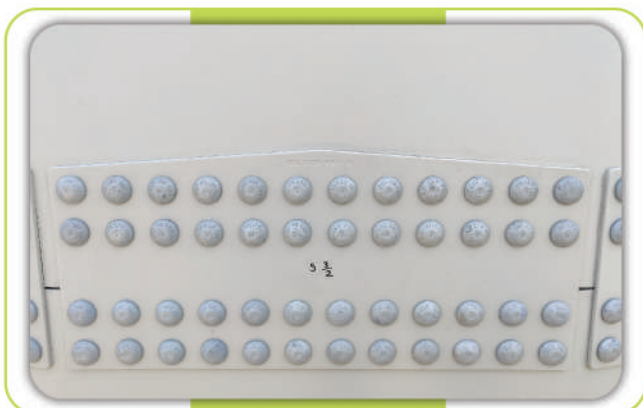
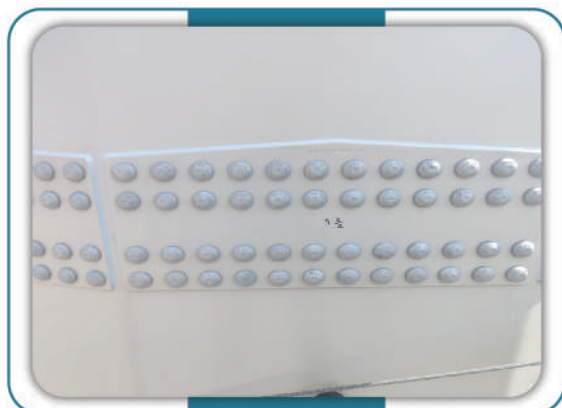
All horizontal cover plates on the tower had been previously sealed during the manufacturing process. This was found to be unsatisfactory and was allowing water to pass behind the plates. It was decided that all previous sealant would be stripped out with the area thoroughly cleaned ensuring a clear surface for bonding of new sealant. Once the area was cleaned, a primer was used to promote superior adhesion for the new sealant. New sealant was then applied providing a much larger seal and better quality than previous. There were also various other sections that included the door and rear vent that were also sealed.

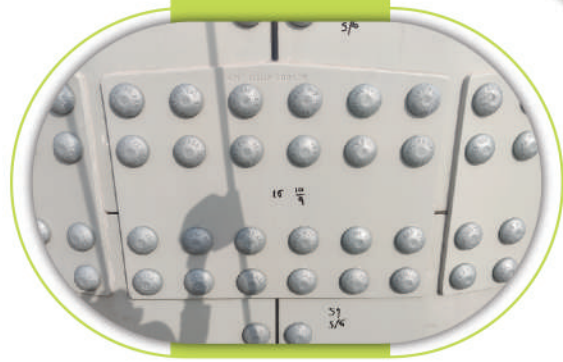
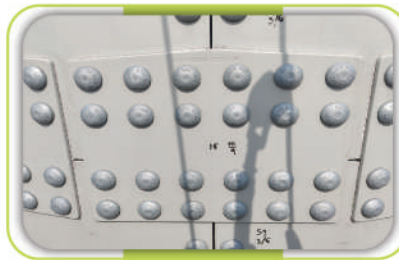
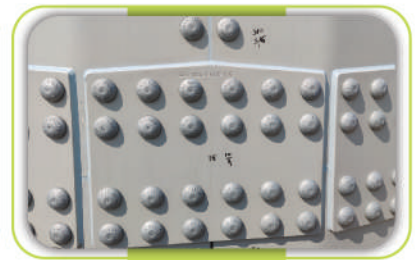
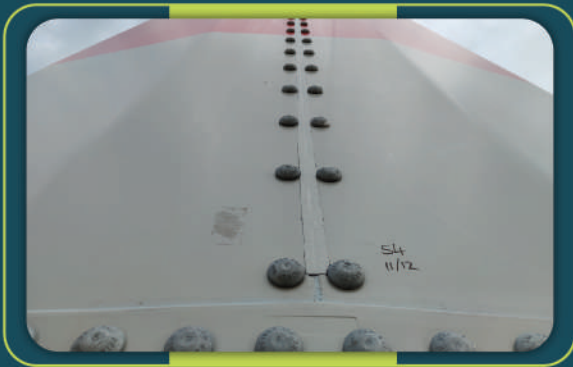
Vertical sections of the tower were previously filled with a special type of foam used during construction. The foam is squeezed into position as the steel plates are forced together. Due to tower oscillations the foam was uneven in places resulting in gaps where water was able to pass through and penetrate the interior.

The solution for this was to remove any protruding foam from the vertical seams. We would then clean the area thoroughly, again to promote adhesion of the specially designed sealant tape.
