CASE STUDY
BROCHURE

BLADE
REPAIR SPECIALISTS

LEADING

EDGE EROSION

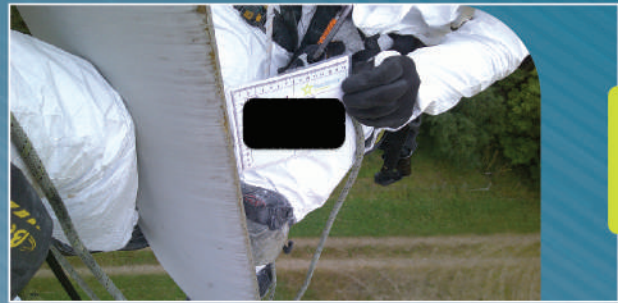
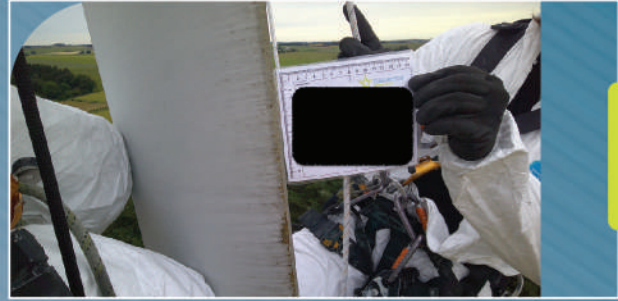
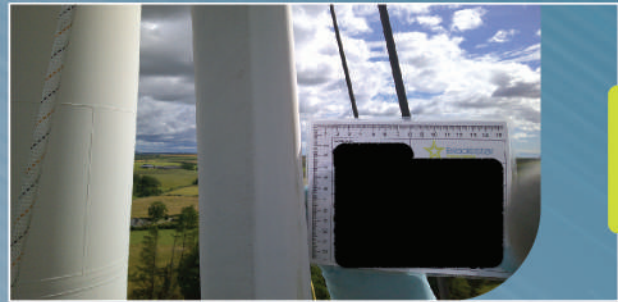
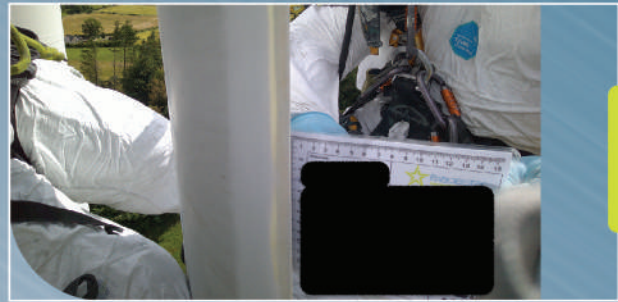
Bladestar Renewables Ltd were tasked with completing Category 2 Leading Edge Erosion repairs on x3 vestas blades. The blades were in general good health however had fallen victim to leading edge erosion with no protection applied at factory.

Each blade had approximately 3 metres of leading edge erosion. The inspection photo's were blurry therefore we were unsure as to the extent of the damage ie; paint, filler or laminate damage.
