Earlsburn Internal

WEB REINFORCEMENT

Bladestar Renewables Ltd were tasked with completing a Category 3 internal repair to a LM blade. The identified defect was a result of operational fatigue.

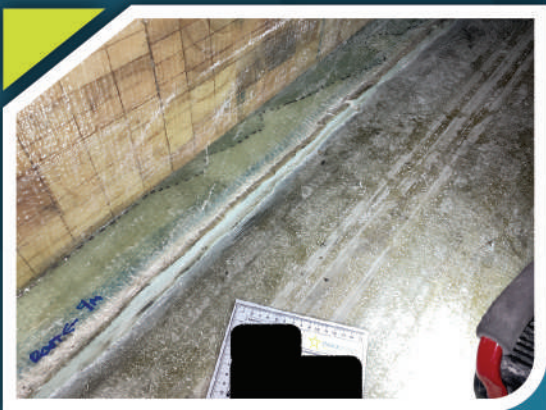
The damage was located 8 metres from the root on the suction side. In section 2 of the blade, Web B had suffered debonding from the internal shell. The total distance of the debonding was around 4 metres.

The repair took 2 days to complete start to finish including setup of habitat. Project was under budget resulting in a very happy customer.
