BLADE
REPAIR SPECIALISTS

MST TOWER SEALING

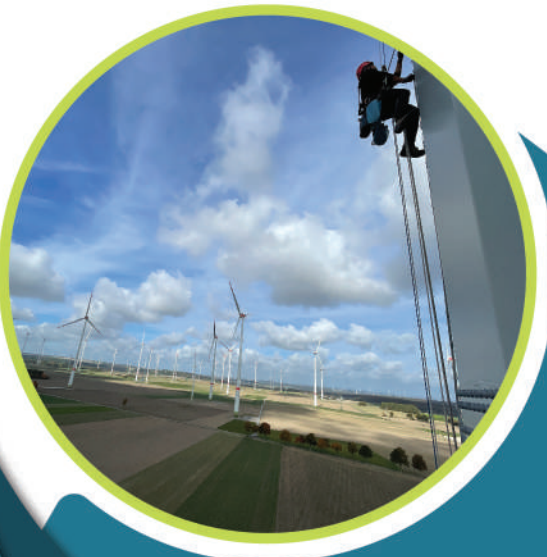
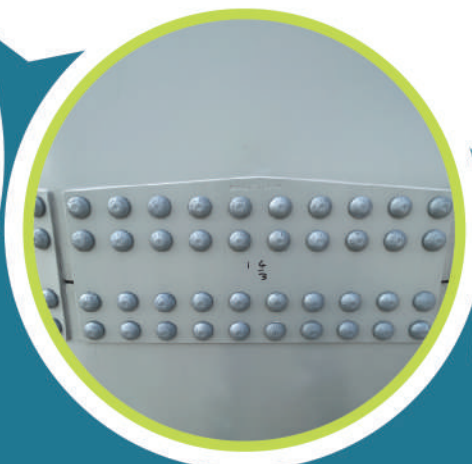
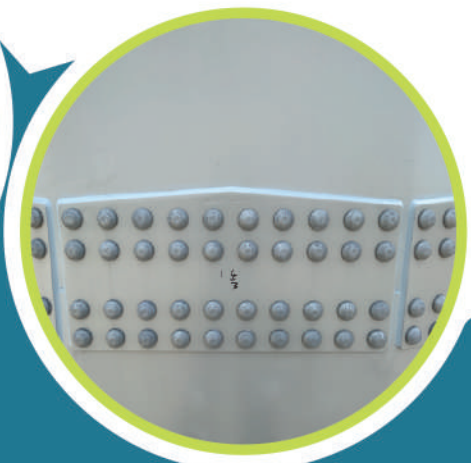
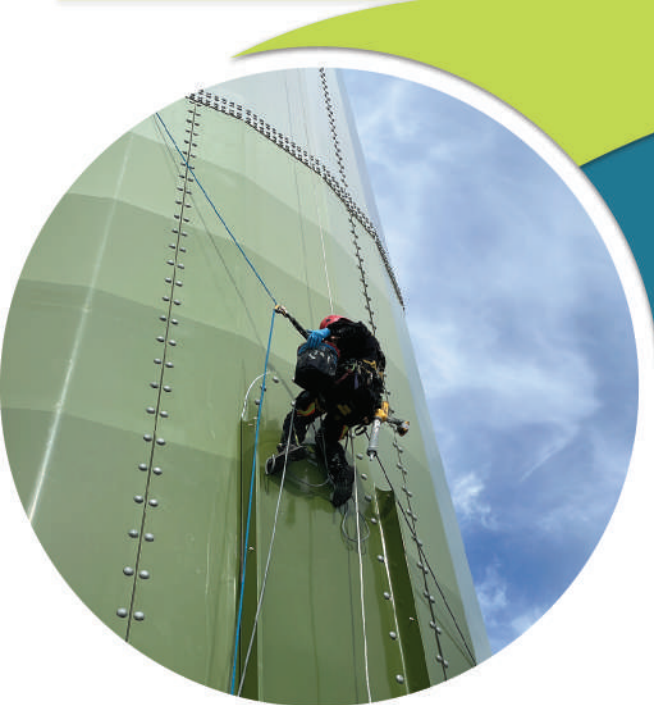
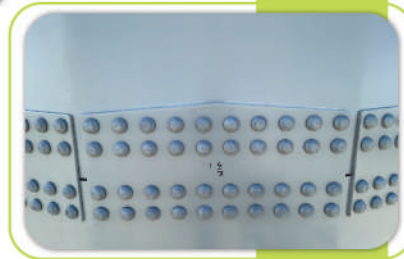
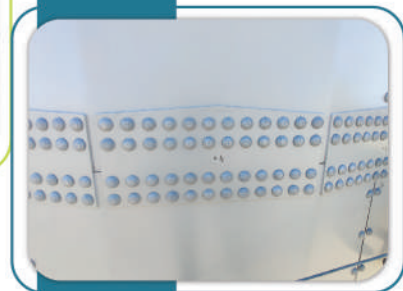
Before beginning any sealing/taping works it was essential that the sections of the tower were split up and marked appropriately. Due to the size and surface area being worked on it would have been very easy to become disorientated and document the wrong sections being worked on. Through meticulous preparation and planning, Bladestar devised an efficient plan for marking up of the tower which would in turn speed up the repair process.

In total there were 11 segments. These varied in number of panels as there were more at the bottom and reduced nearer the nacelle. There were x24 horizontal cover plates on each segment resulting in a total of 264 horizontal cover plates being sealed. There were 98 vertical seams on the tower which resulted in a total of 1078 metres of taping to be applied.
